LOST ROV LOCATED

Shipwreck Hunter recovers his ROV after 8 years at the bottom of Lake Michigan

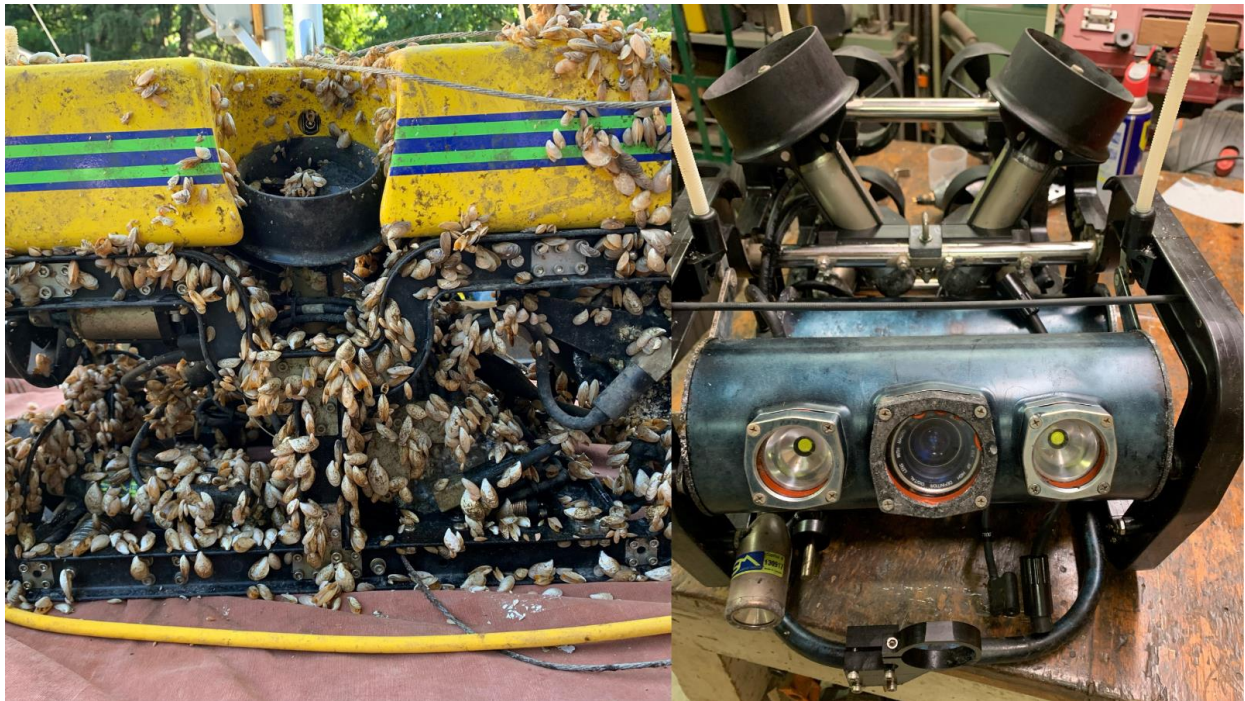
BEFORE & AFTER

After the successful recovery, the shipwreck hunter spent 12 hours power washing and cleaning his SEAMOR ROV then tried starting it. It fired up immediately! After spending eight years at a depth of 134 meters (440 feet) in Lake Michigan, the ROV had no visible leaks, only a bit of corrosion at both ends of the thrusters, and just two parts that needed to be replaced: the gripper and one light. The camera and lights worked for about 30 seconds, the propellers on the thrusters turned freely, the cylinder with the circuit boards was bone dry and the cylinder with the camera & lights appeared to be dry.

1. SEAMOR Legacy 300T back side before and front side after
2. SEAMOR Legacy 300T straight out of the water
