CONDITION ASSESSMENT INSPECTIONS

Inspections by SEAMOR's Chinook ROV determined the condition of a neglected railway bridge foundation in the Netherlands.

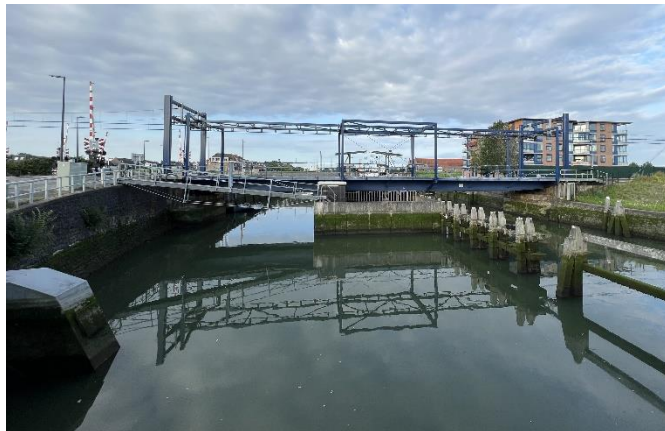
an existing section of 24 kilometer's railway track between Rotterdam and Hook of Holland, the public transport company (RET) needed to assess the condition of the infrastructure. This particular section of busy track included a bridge over the Port of Maassluis that's underwater portion, hadn't been inspected for more than 130 years. To determine if the bridge's foundation met the NEN 2767 compliance

1. Bridge over the Port of Maassluis
2. Concrete and wood integrity measurement device

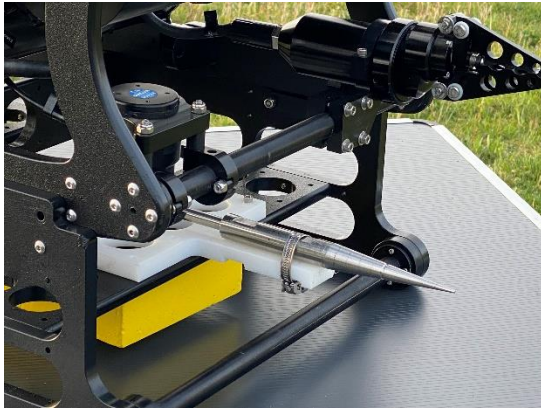
maneuvering the ROV with only 10cm clearance on the top and bottom. A concrete and wood integrity measurement device, developed by DroneQ and validated by Saxion University, was used to gauge the thickness of the bridge foundation.
