TUNNEL INSPECTIONS

Long-range tunnel inspections by SEAMOR's Chinook ROV improve cost efficiency and minimize environmental impact at hydroelectric power plant in Panama

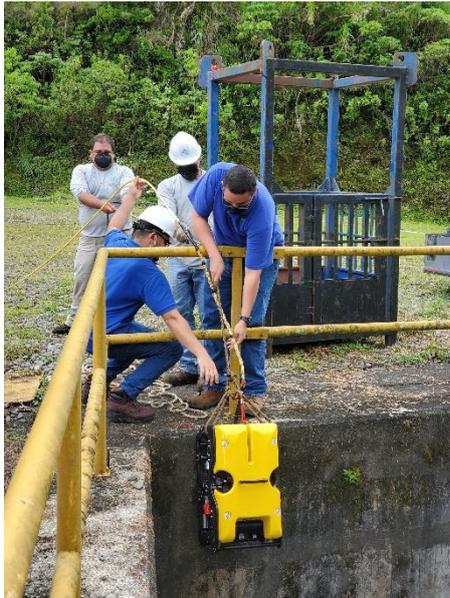
For the inspections, EISA used a Chinook ROV and 3-kilometer fiber optics tether. Able to dive to 600 meters (2,000 feet), the ROV was equipped with a sensor skid carrying two Imagenex sonars: the 965A digital multi-beam imaging sonar and the DT360 multi-beam profiling sonar. These sonars were operated simultaneously using an Ethernet switch to the fiber optic tether multiplexer, allowing the EISA team to navigate and inspect tunnel walls in

1. Pando hydroelectric power plant on the Old Chiriqui River – ariel shot
2. Pando hydroelectric power plant dam
3. SEAMOR Chinook being lowered for inspection
